Corrosion Technical Bulletin 16

May 2019. Revision 5. This issue supersedes all previous issues.

Immersion

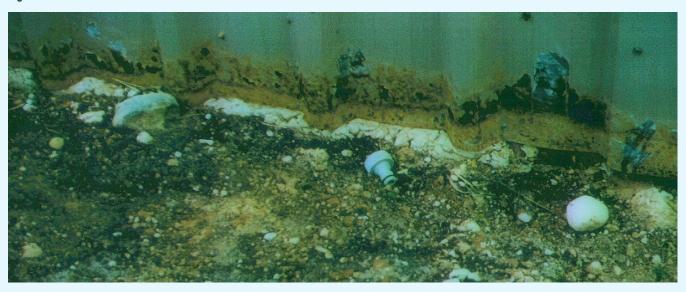
Figure 1: Immersed Shed Wall

In typical garden applications such as fence panels, garden sheds and walling the buildup of grass cuttings, leaves, soil from gardens, mulch, compost, sand and ashes must be avoided. Failure to prevent this build up will cause premature corrosion of COLORBOND® steel, ZINCALUME® steel or zinc-coated steels as a direct result of mechanisms associated with the

wet poultice held against the coated steel surface
