Prevention of sunscreen damage

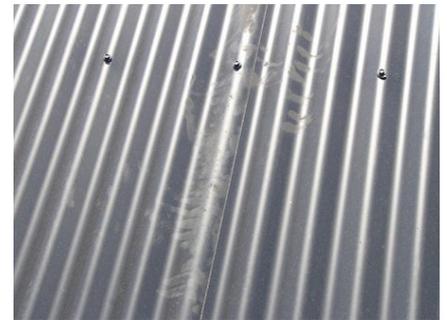
Figure 1. Roofing with sunscreen damage

Although sunscreen damage is irreversible it will not affect the corrosion performance of the material. The sunscreen affected areas cannot be cleaned and attempts to do so may ultimately impact on the corrosion performance of the material. If aesthetics are a concern, BlueScope recommends that the material be replaced.

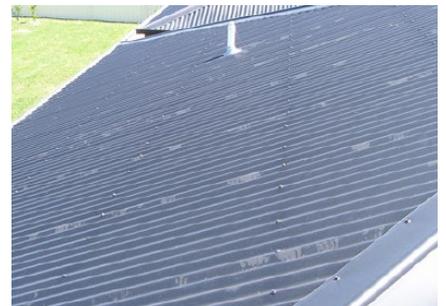
Figure 2. Roofing with sunscreen damage
