Identification of fungus in the field and recommendations for its removal

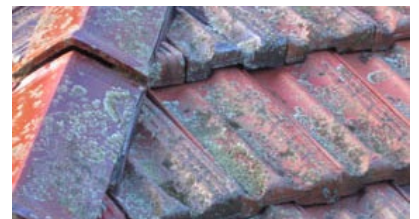
Figure 1. An example of lichenous growth across the surface of a tiled roof

COLORBOND® steel is no more prone to fungal growth and discolouration than any other building material. For example, roof tiles, painted wood, PVC pipes, powder coated handrails and glass or polycarbonate sky-lights are also prone to fungal growth and discolouration. As such, where fungal staining is observed on COLORBOND® steel installations, neighbouring structures and fences will typically also show similar effects of infestation. In cases where the local environment is particularly favourable, lichens may also be occasionally seen, usually across the entire roofing surface. Figure 1 provides an example of lichenous growth on a tile roof.

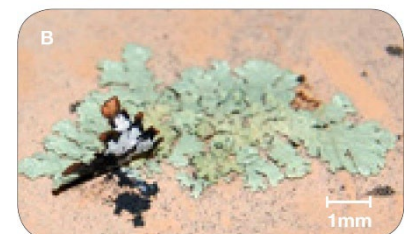
Figure 2. A close up of a) fungal and b) lichenous growth

Areas affected by fungus may be divided into several basic types based on organism and distribution. Organisms visible on roofs can be broadly divided into fungus and lichen (a symbiosis of fungi and algae). While fungus is generally black, lichen appears green and often leafy. See Figure 2.

It is then recommended that a spot test with sodium hypochlorite solution be carried out. The most convenient source of sodium hypochlorite is household bleach. The bleach should be as fresh as possible and the hypochlorite/available chlorine concentration should preferably be above 3%. Care should always be taken when handling the solution as it is alkaline. Rubber gloves should be worn and always follow the manufacturer’s safety instructions. Any tested areas should be thoroughly rinsed with fresh potable water afterwards.

To test, apply a drop of the bleach solution to a suspected area, mark the extent of the drop unobtrusively (for example, with a pencil) and wait a few minutes. If fungus is present, the dark material will be destroyed by the bleach and a clean drop area will result.

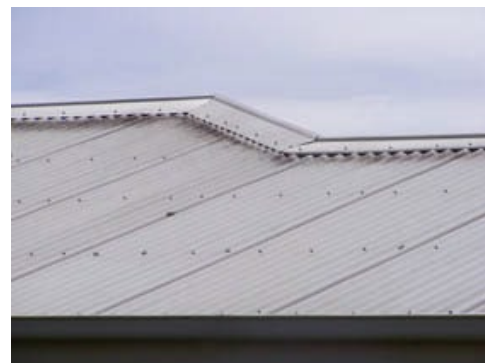
Heavy areas of fungal infestation on a building are often seen around the ridge-capping. See Figure 3.

It is believed that this “ridge cap” effect is due to the favourable micro-environment for fungal growth which exists in this area because of moisture and/or nutrients leaving the roof cavity at the junction of the ridge capping and the roofing sheets.

Figure 3. Roof made from COLORBOND® steel showing isolated fungal growth near the ridge capping

To clean a COLORBOND® steel roof it is recommended that the roof be washed down with a 2% sodium hypochlorite solution. The sodium hypochlorite solution can be made up from commercially available bleaches. To assist in making up the solution, Table 1 shows the dilution required for different strength bleaches to give a 2% solution.

The bleach should be applied with a soft bristle broom, left for 3-5 minutes, and then washed off with copious amounts of fresh potable water. A small amount of non-ionic detergent, such as dishwashing detergent, may be added to the bleach if necessary to improve wetting.

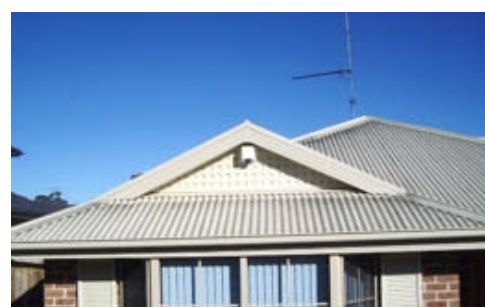
It is also possible for growth to not be isolated to any specific area but to cover the entire roof area. Such growth is normal on any outdoor structure where the local environment is conducive. When very heavy growth of this type occurs on lighter coloured roofs, the overall colour and appearance may be altered. See Figure 5.

Figure 5. Roof made from COLORBOND® steel showing uniform coverage of fungus
